BUILDING CONDITION ASSESSMENT

Prepared for:
Forum Theater Building
312-316 Main Street
Middlesex, New Jersey

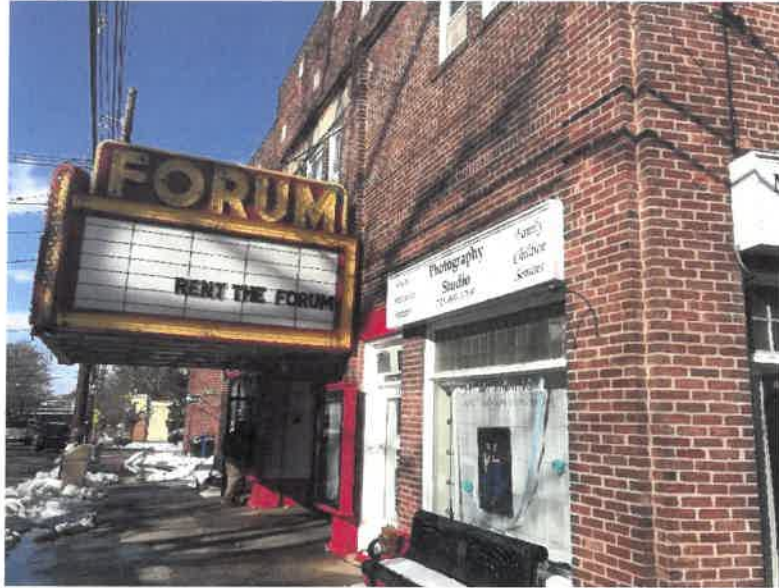
Figure 1. Front/West Elevation w/Marquee

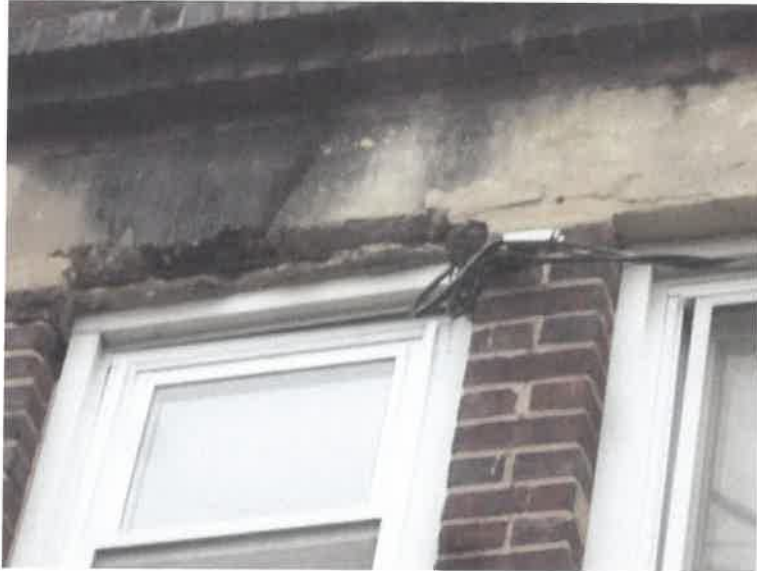
Figure 3. Spalled Concrete Lintel at Front/West Elevation Typ. 3 Locations (Balcony Level)

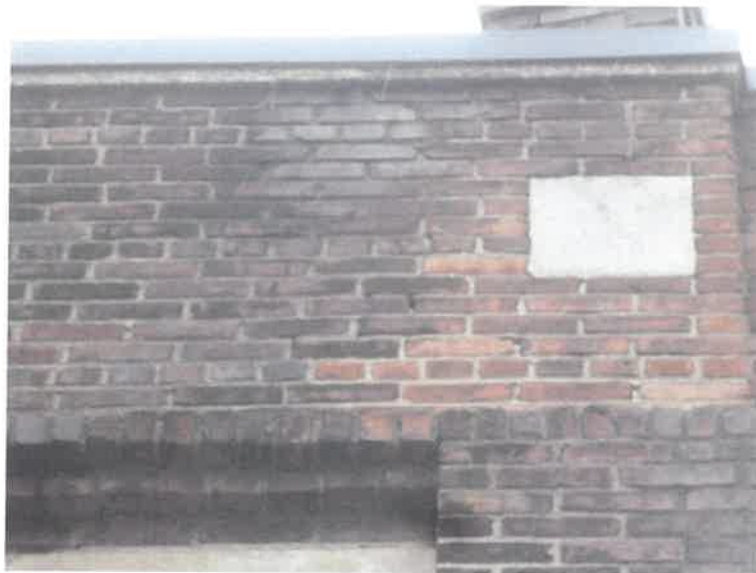
Figure 4. Deteriorated/Open Joints at Parapet Wall (Front/West Elevation)

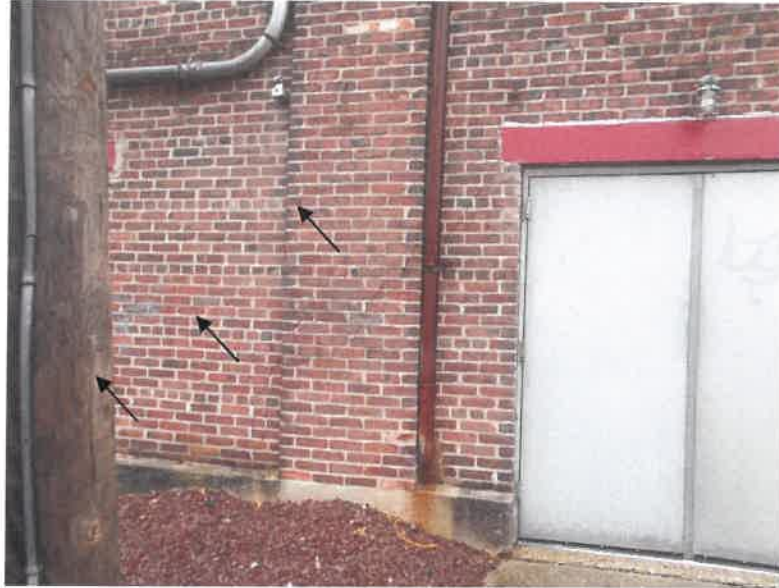
Figure 5. Cracked Brick Masonry (North Elevation)

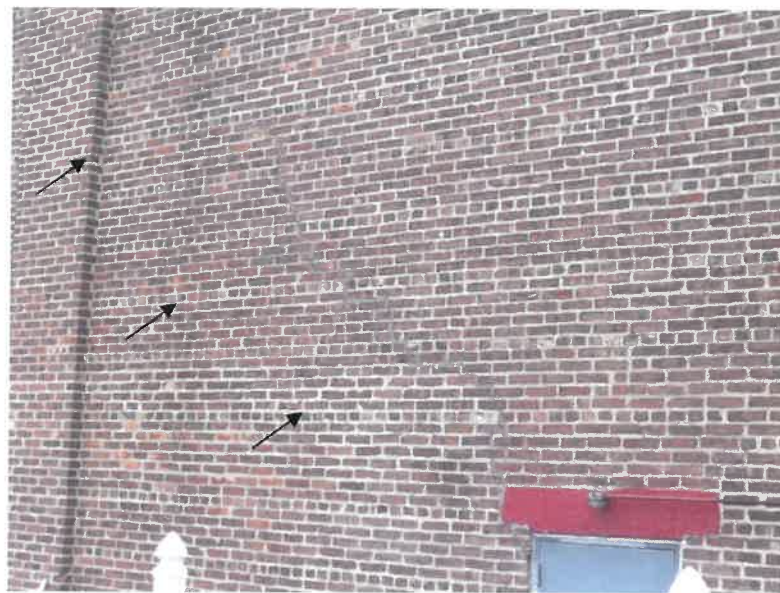
Figure 6. Cracked Brick Masonry (South Elevation)

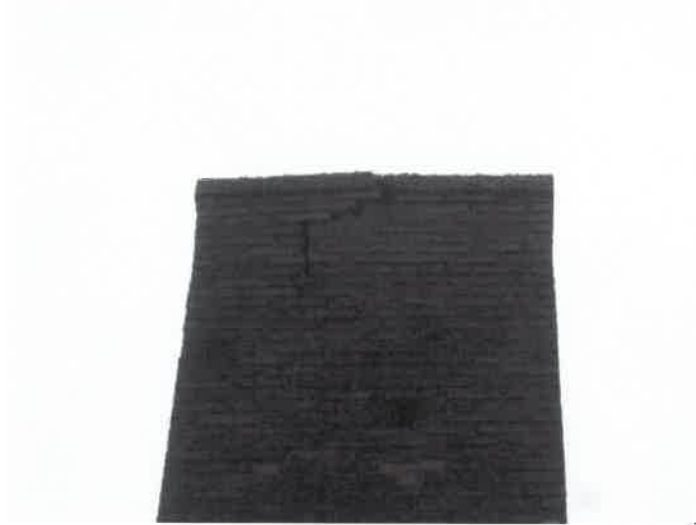
Figure 7. Significant Crack and Displacement of Masonry Chimney at Southeast Corner

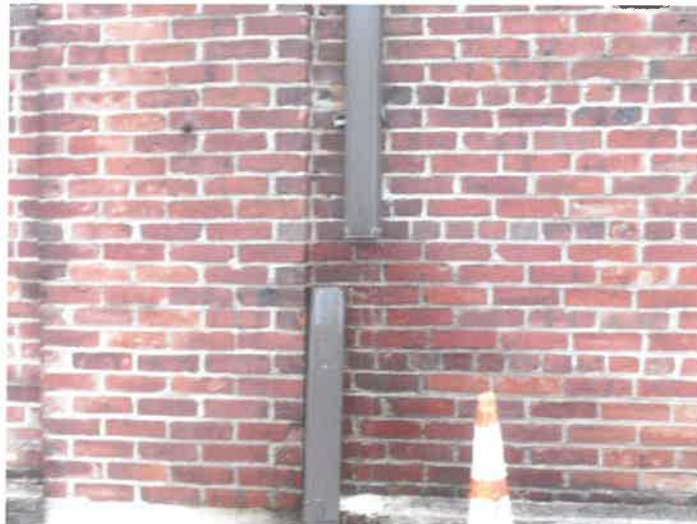
Figure 8. Detached Rain Leader (Downspout) at North Elevation

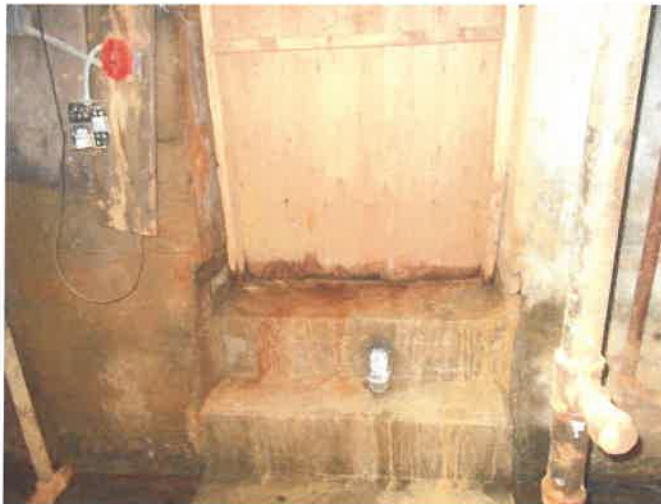
Figure 10. Water Infiltration at Cellar Level Through Abandoned Exit

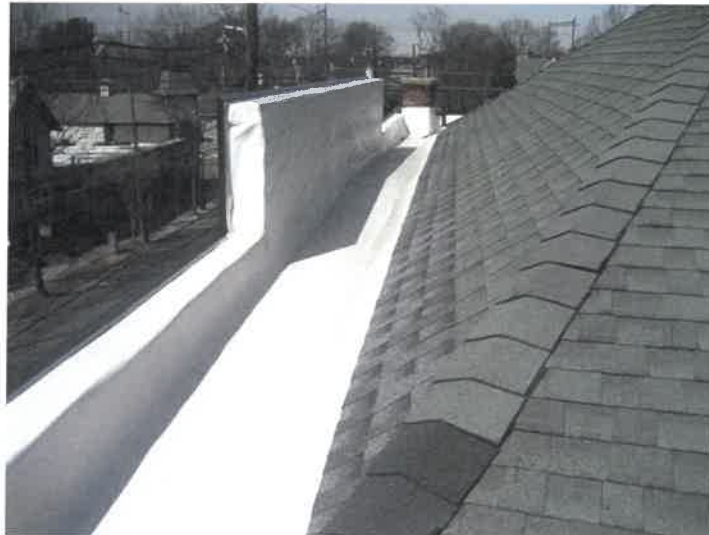
Figure 11. Overall View of Main Roof Area

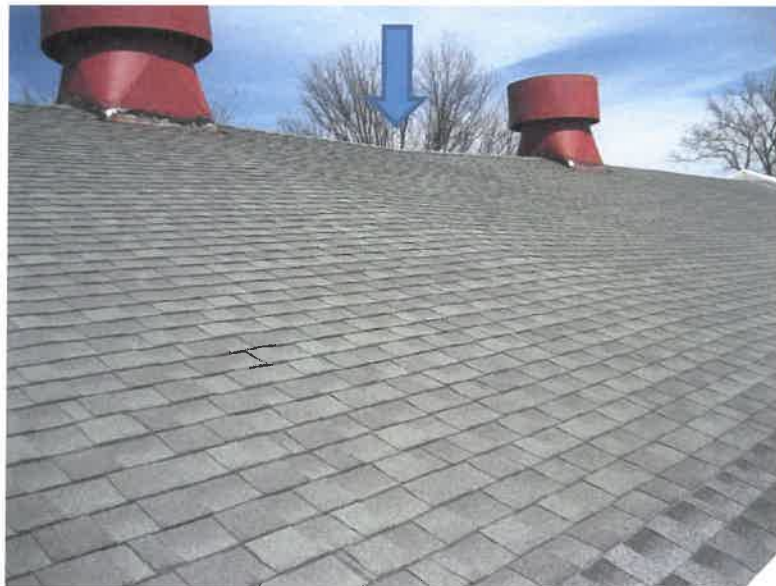
Figure 13. Depressions in Roof at Truss Damage

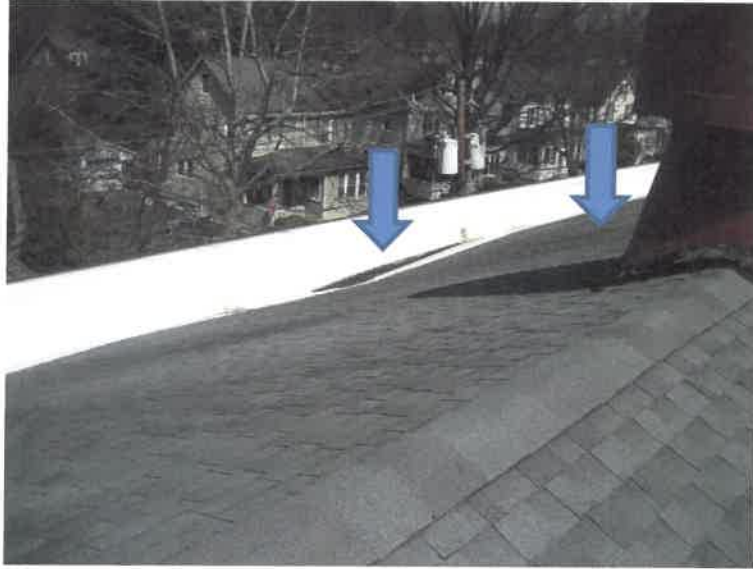
Figure 14. Depressions in Roof at Truss Damage

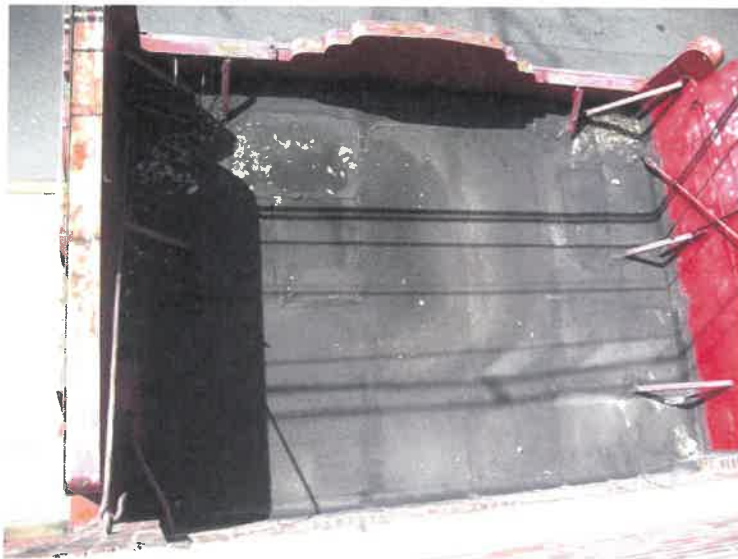
Figure 15. Overall View of Marquee Roof

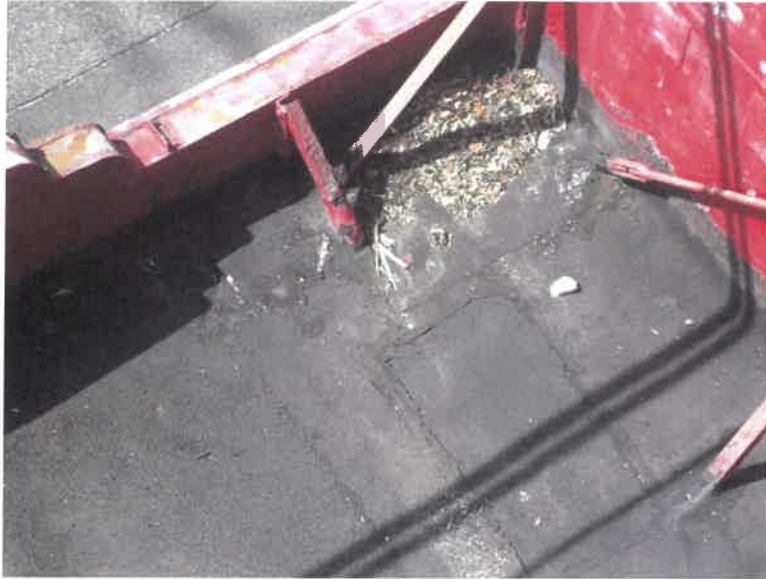
Figure 16. Debris Accumulation and Use of Roof Cement for Flashing

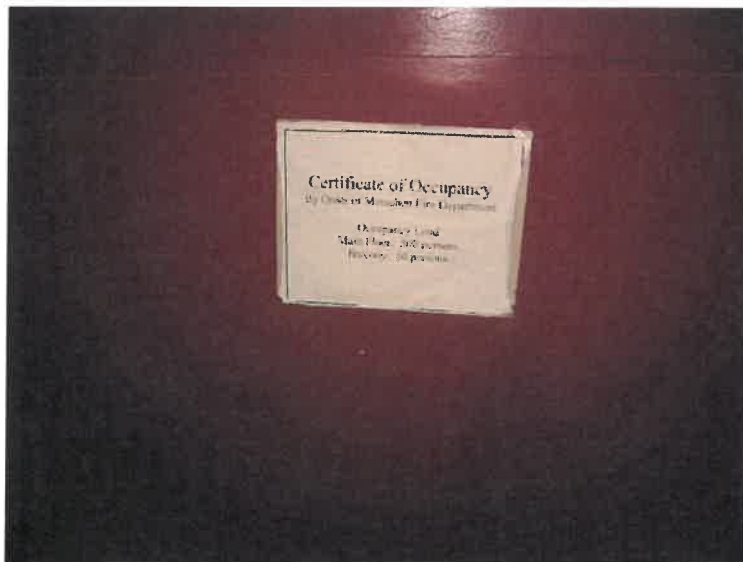
Figure 2. Observed occupancy chart.

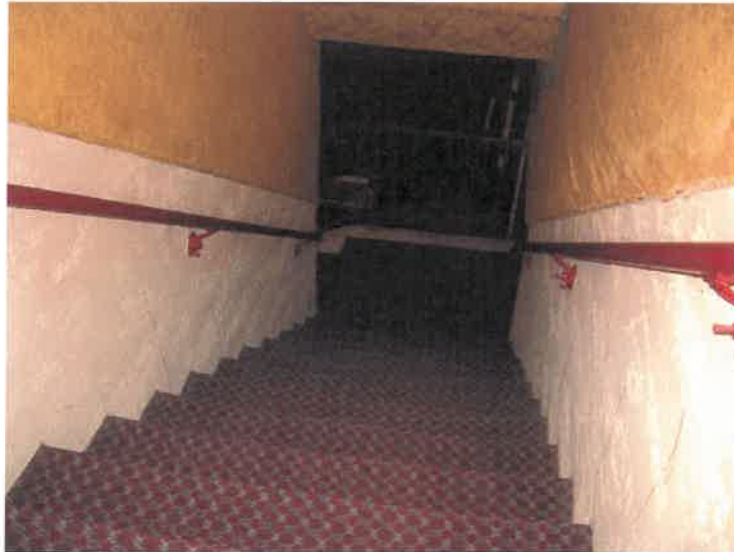
Figure 3. The existing stairs do not meet current code requirements for egress and accessibility

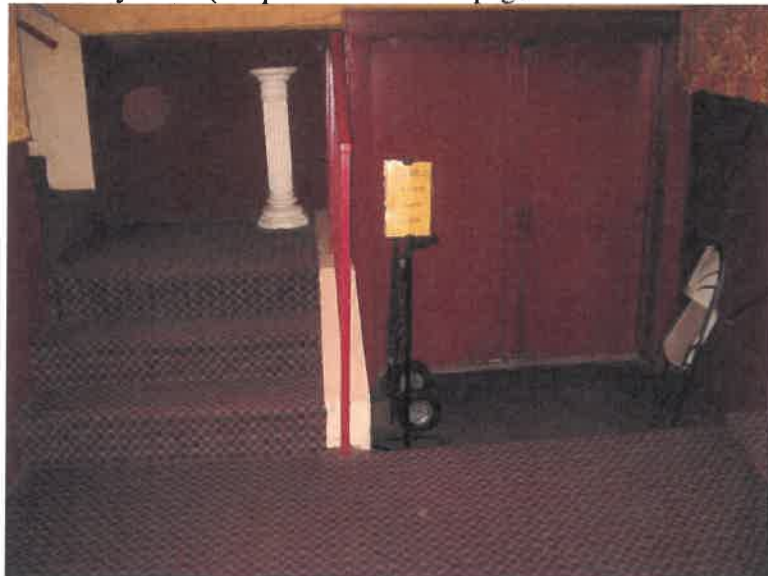
Figure 4. This emergency exit does not meet current code requirements for egress.

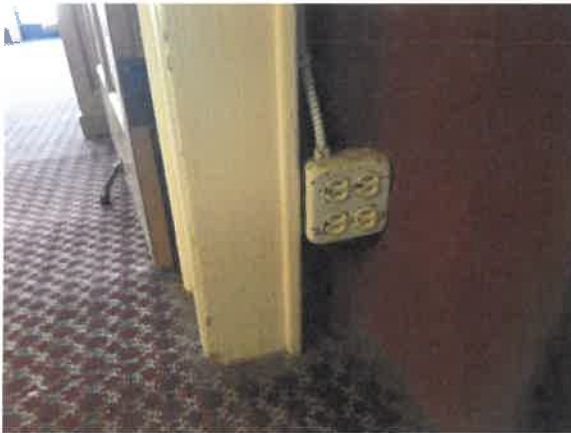
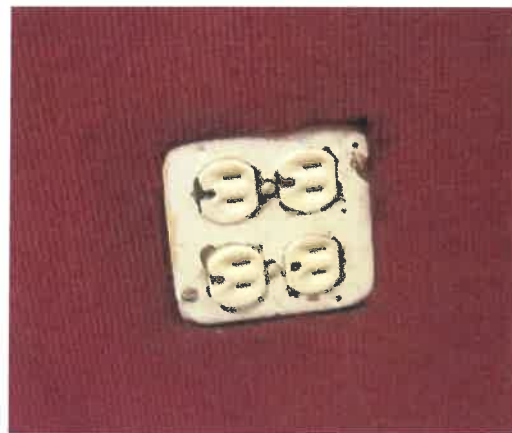
Figure 1 and 2. Typical receptacle.

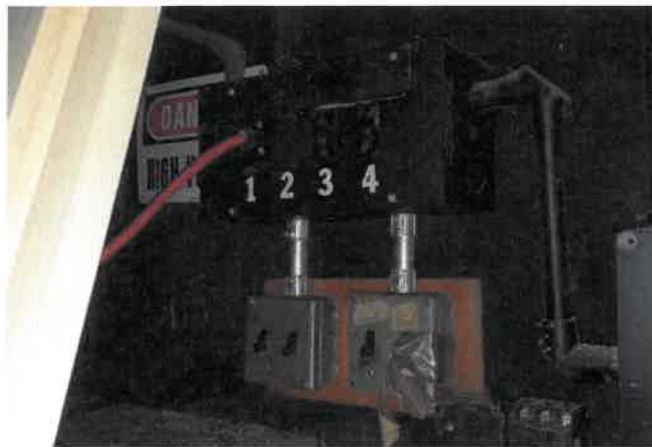
Figure 6. Company switch block with damaged connection.

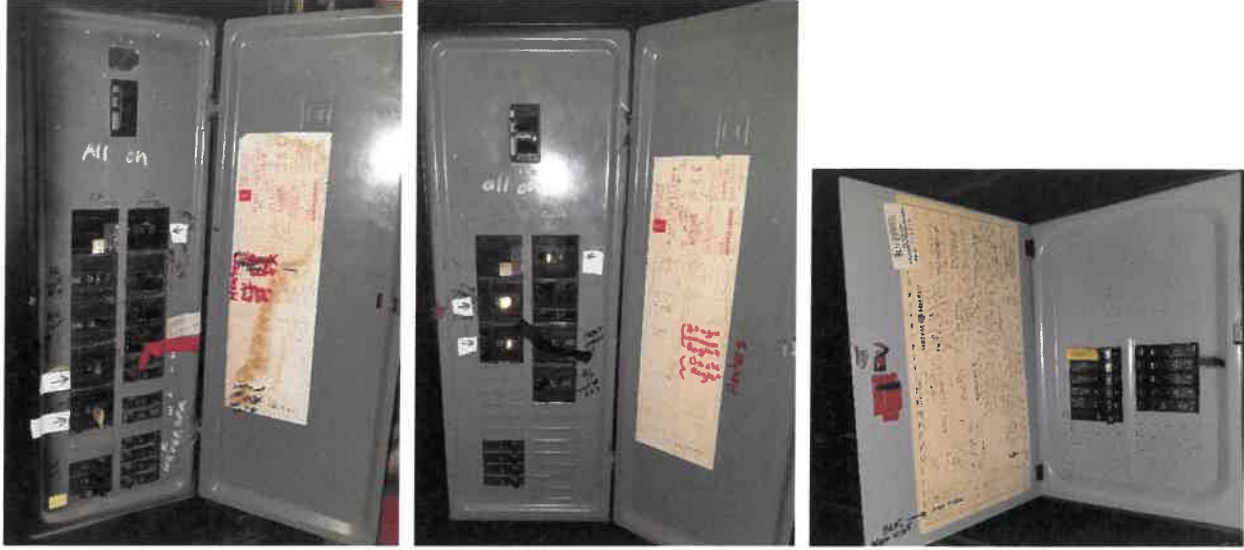
Figure 7, 8, and 9. Panels at electrical service entrance in stage area.

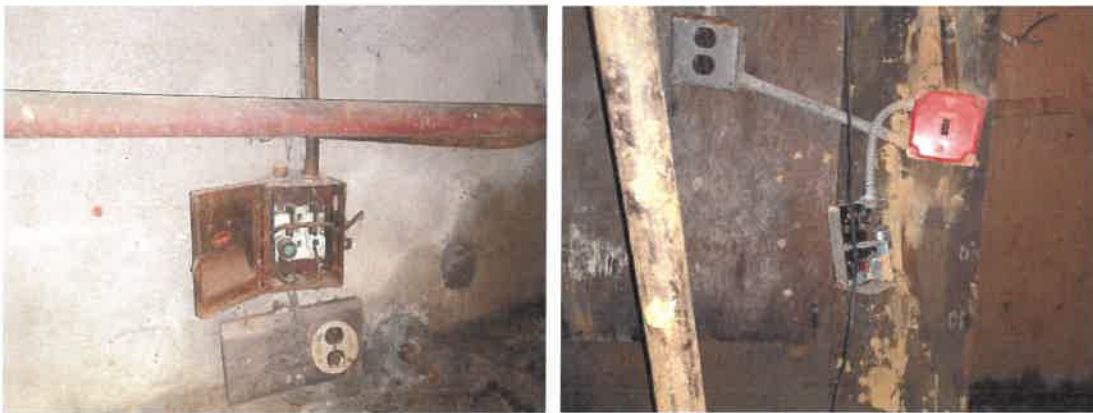
Figure 12. Typical corroded/abandoned devices in old boiler room.

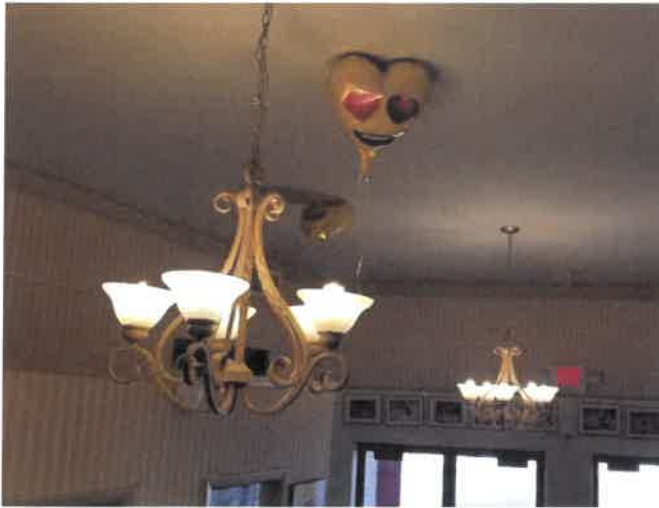
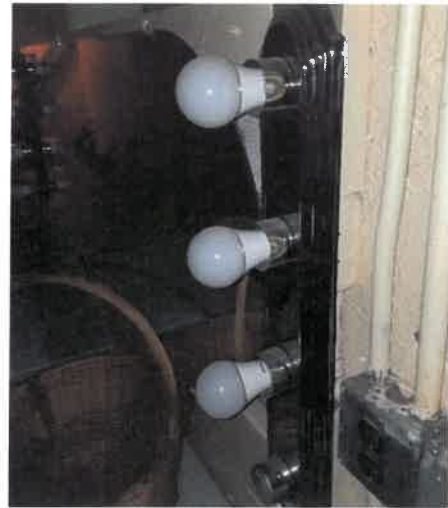
Figure 13 and 14. Typical lighting retrofit with CFL/LED bulbs (entrance and vanity mirrors)

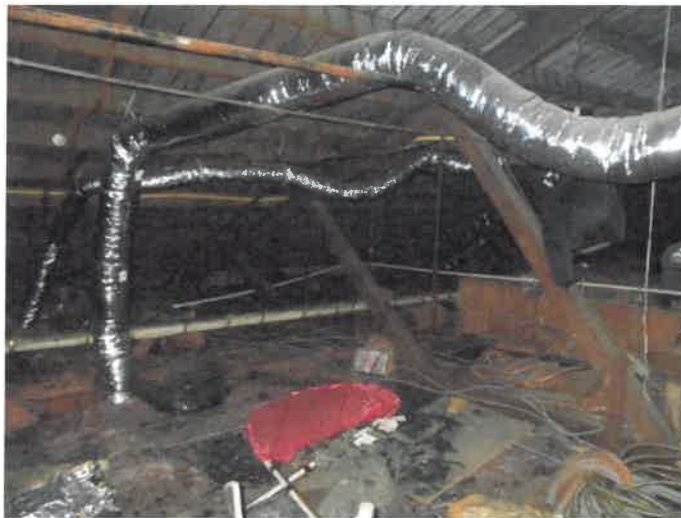
Figure 1. Roof Framing (Note Timber Truss and Roof Purlins)

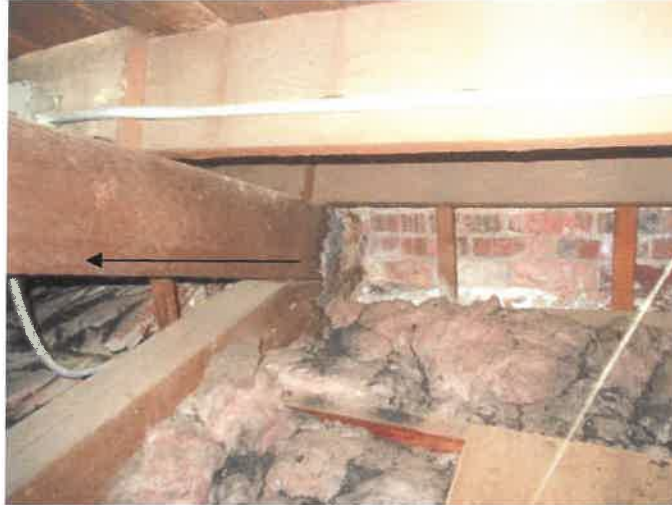
Figure 2. Timber Truss with Moisture Damage at Bearing Location (Exterior Brick Wall in Background)

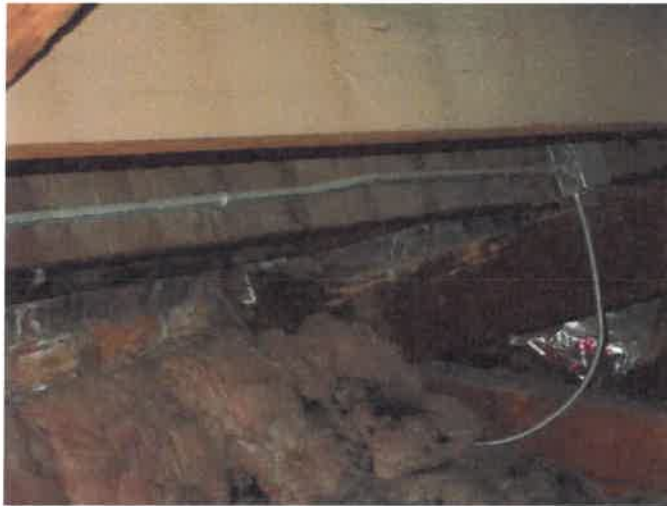
Figure 3. Cracked Timber Truss at Bearing Location

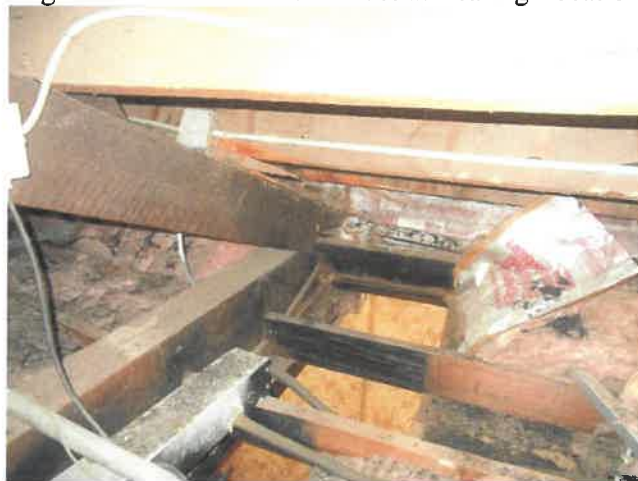
Figure 4. Severely Cracked and Displaced Roof Truss at Exterior Wall Support

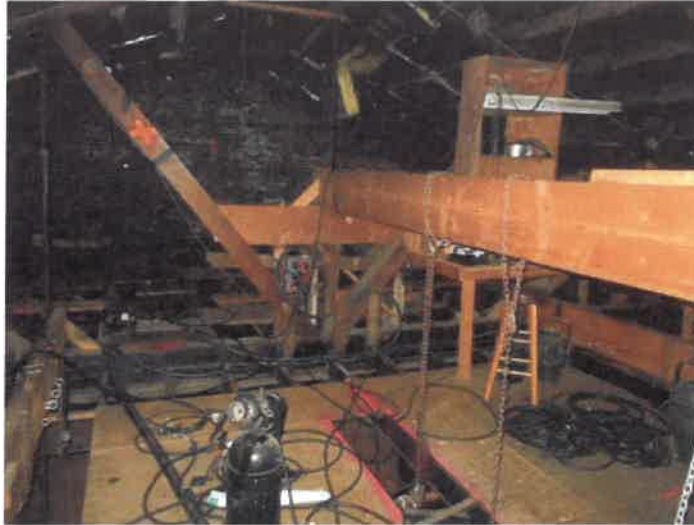
Figure 5. Stage Lights and Prop Hoisting Equipment on Inadequately Sized Attic Joints (Note Lack of Guardrails and Openings in Floor Creating Workplace Hazards)

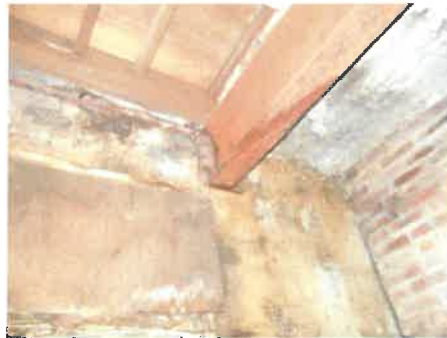
Figure 1. Localized Corrosion of Steel Framing at Rear/East Foundation Wall

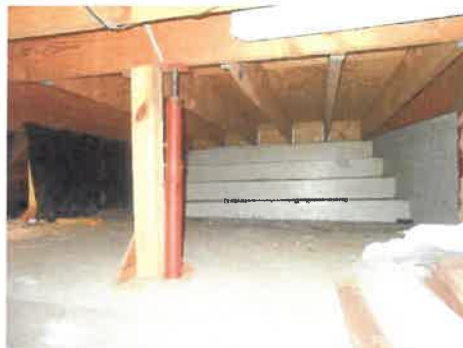
Figure 2. Wood Stage Framing (Joists Over-spanned for Required Loads, Improper Girder Dimensions, Improper Support Post Anchorage, Note Temporary Steel Shore Post in Place)
