AREA IN NEED OF REDEVELOPMENT PRELIMINARY INVESTIGATION OF THE METUCHEN ARTS DISTRICT

Borough of Metuchen, Middlesex County, New Jersey

Prepared by LRK, Inc.

November 29, 2018

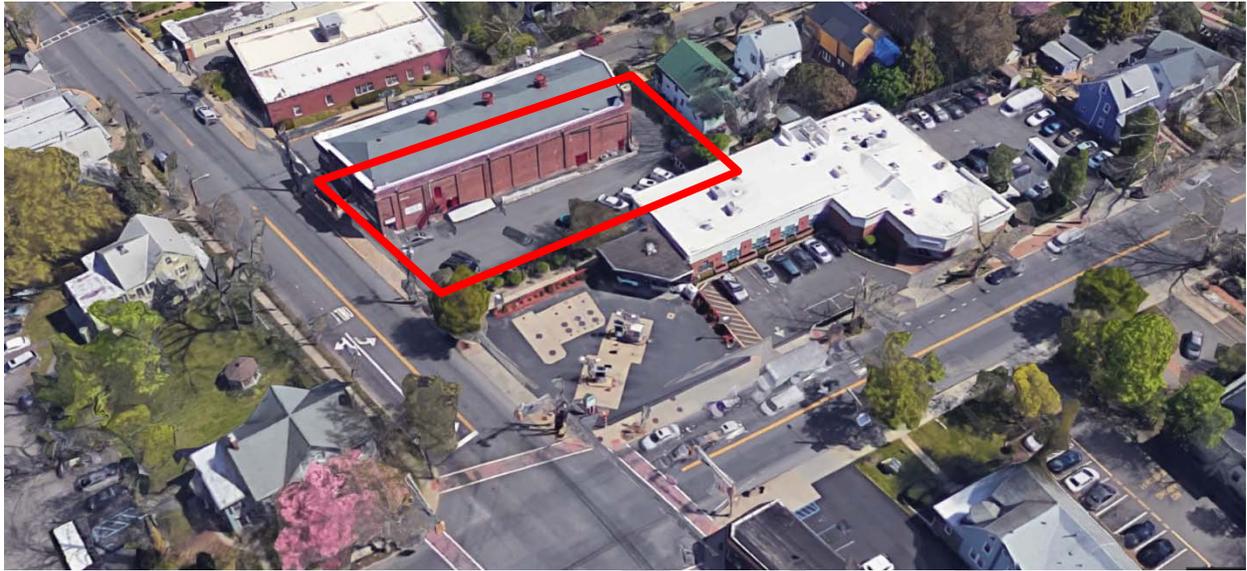
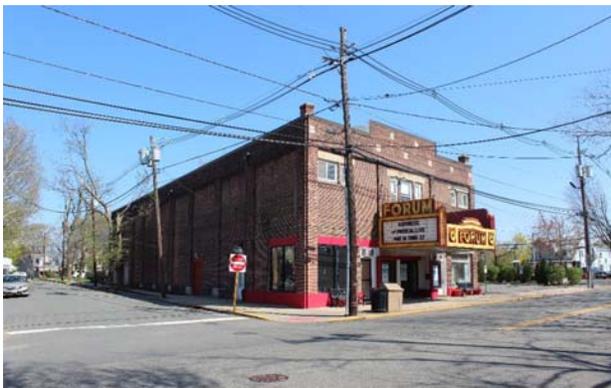
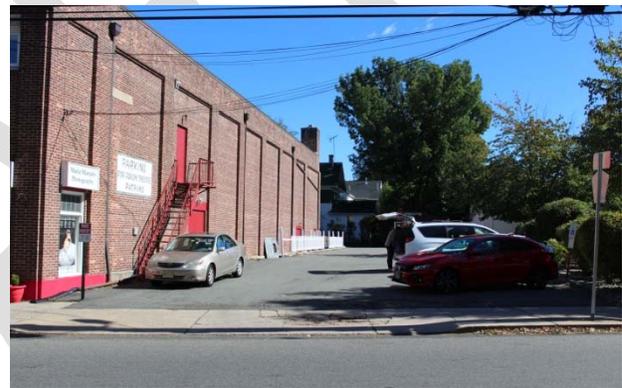
Block 183.02, Lots 1-4, 31-32: 312-316 Main Street (Forum Theatre)

Block 183.02, Lots 1, 2, 3, 4, 31 and 32 is a corner lot, with 97.01 feet of frontage along the east side of Main Street and 164.34 feet of frontage along the south side of Bissett Place, and having an average depth of 154.51 feet as measured from Main Street. This property contains a 2-story theater with a basement. Attached to the front of the building is a large marquee sign projecting over the Main Street public sidewalk. There is a parking lot to the south of the building serving employees and/or patrons, with access from both Main Street and Bissett Place. The property is nearly 100% impervious.

The access point from Main Street is intended as a one-way ingress into the property, providing access to a single row of angled parking stalls along the southern lot line. The parking lot drive aisle wraps around to the rear of the building to a one-way egress to Bissett Place.

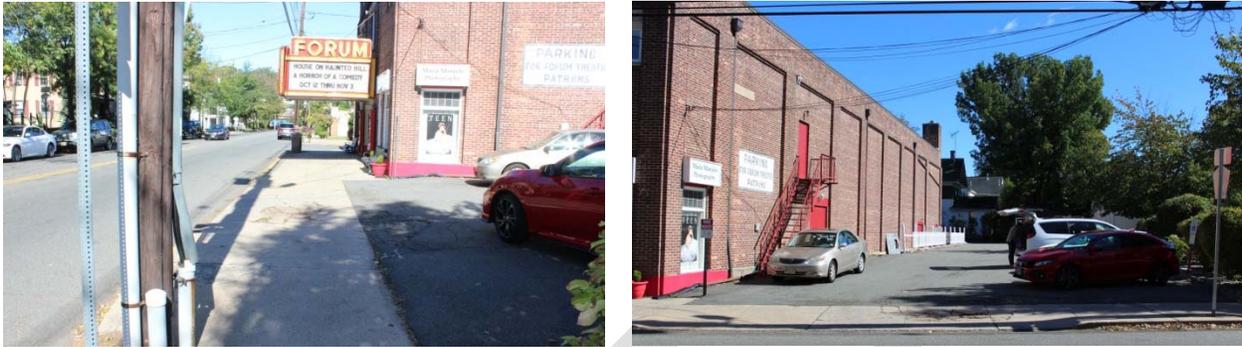
Parking Lot Layout & Design

The present layout of the parking lot is obsolete by current site planning standards because it does not provide an adequately designed single-lane vehicular ingress drive and egress or defined parking areas.

The pavement of the driveway and parking lot extends to the public sidewalk along Main Street without any drive aisle definition, parking stall buffering or delineated edge (i.e., a curb or a landscaped area), which promotes unsafe maneuvering where vehicles have an excessively wide apron crossing the sidewalk into the driveway and where vehicles can back out of stalls into pedestrians utilizing the Main Street public sidewalk.

For what is intended to be a one-way driveway, the excessive width, the significantly faded painted arrow in the parking lot drive aisle and the lack of any signage indicating that the driveway is one-way only contribute to a lack of safety for both motorists and pedestrians.

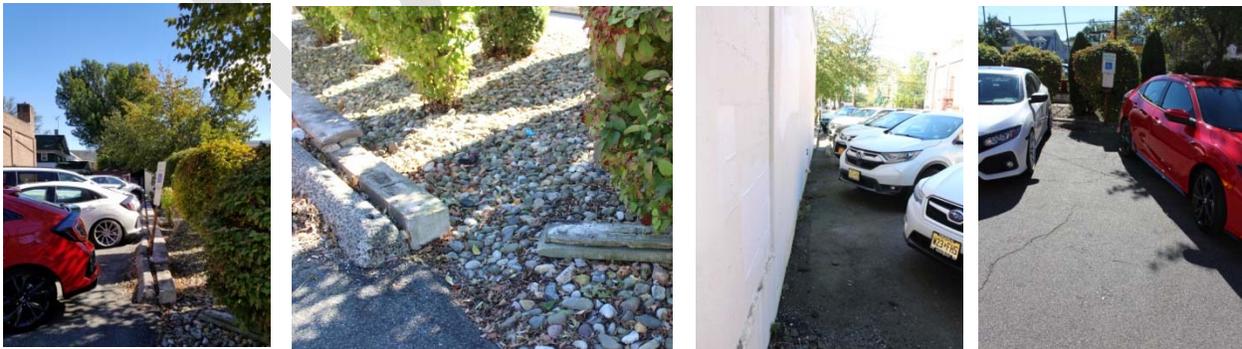
While most parking stalls feature wheel stops, the majority of them have either shifted or are in a state of disrepair, and therefore no longer serve their purpose. There were no wheel stops whatsoever at the rear of the parking lot, along the rear of the University Radiology

building, which may potentially contribute to property damage.

Additionally, striping delineating parking stalls is non-existent, as they too have faded significantly. There also did not appear to be a handicap-accessible access aisle provided. Finally, various areas of the parking lot show signs of deterioration as evidenced by vegetative overgrowth, settlement contributing to ponding, as well as cracked, broken and missing pavement.

As such, the deteriorated and dilapidated conditions, faulty arrangement or design and obsolete layout of various parking lot improvements are detrimental to the safety, health, morals and welfare of the community.

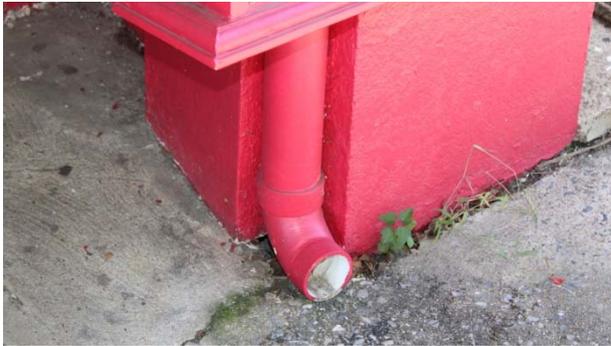
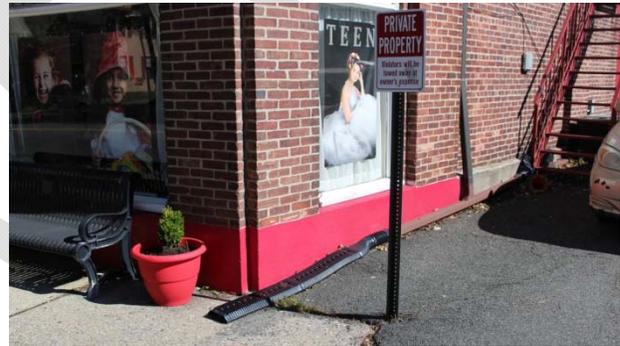
Streetscape Conditions

The property generally lacks stormwater management control, particularly along Main Street, simply allowing downspouts to discharge stormwater onto the public sidewalk. In any rain event, stormwater may sheet flow across the public sidewalk. In winter weather, this may potentially present an icing hazard for both pedestrians egressing the building and passersby on the public sidewalk.

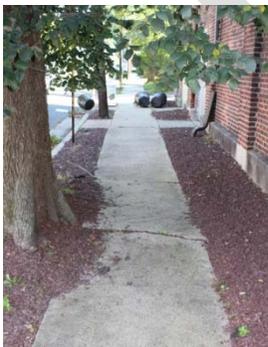
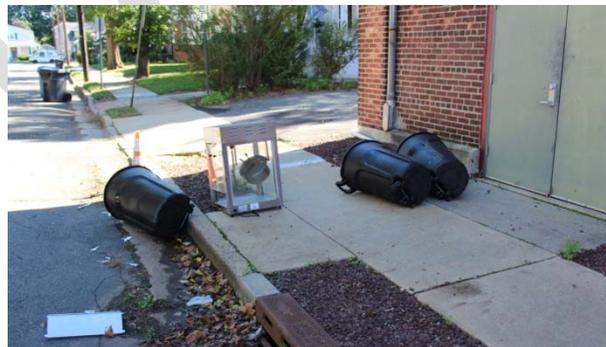
Along Bissett Place, there are small loose stones located on both sides of the public sidewalk and may not be permitted. Migration of loose stones into the path of the public sidewalk or in the street may potentially present a tripping hazard and contribute to property damage.

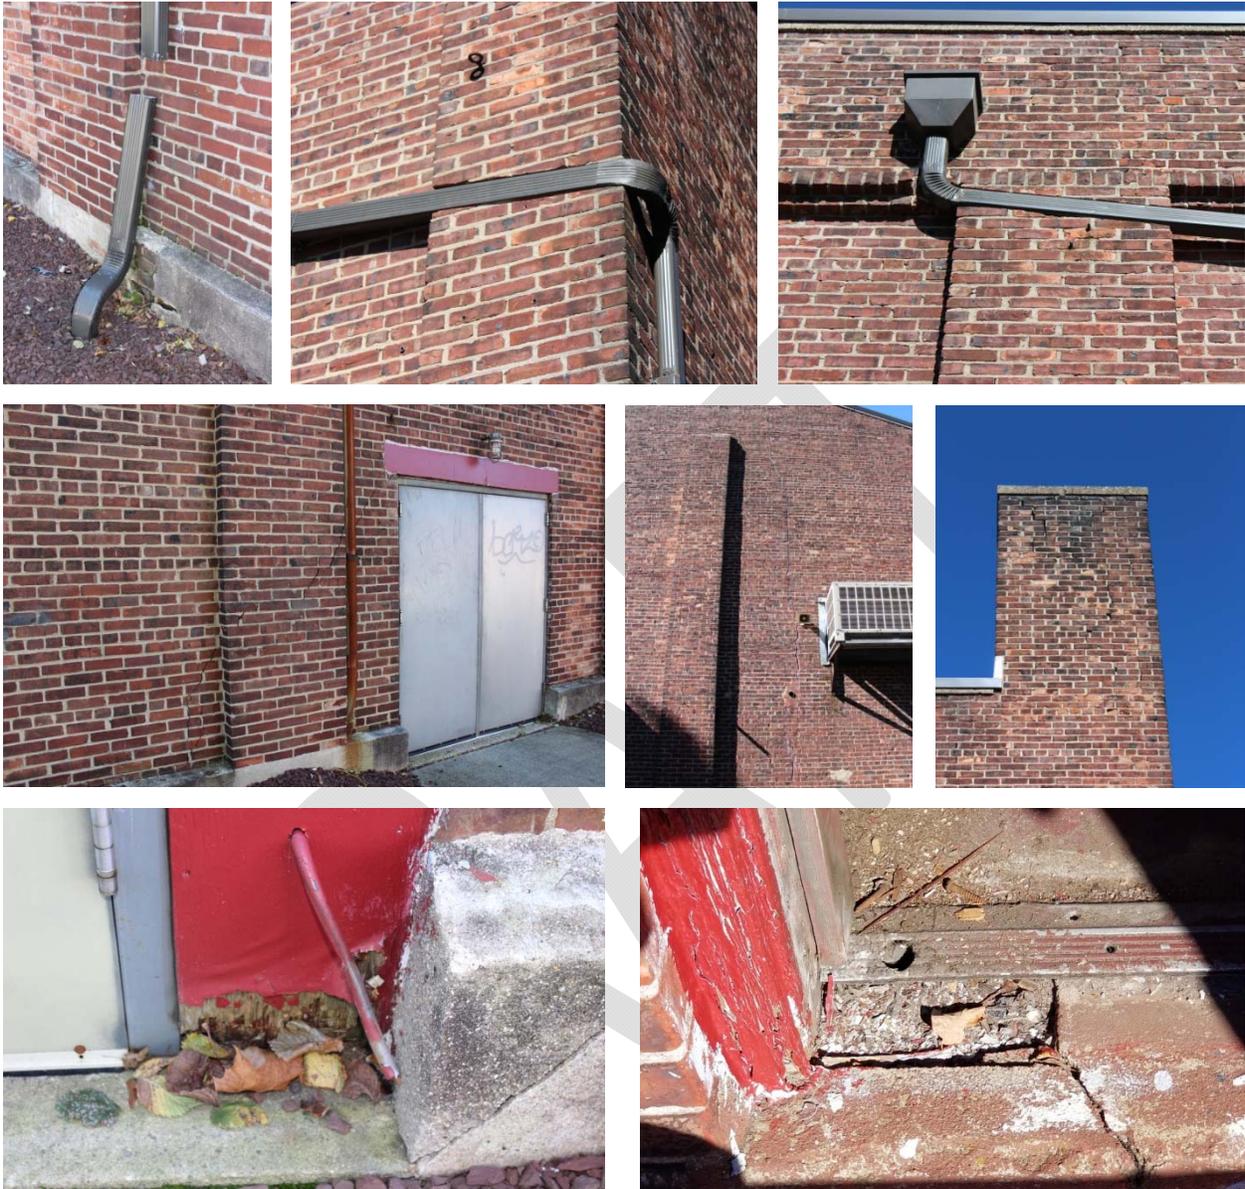
Building Exterior Conditions

The exterior of the building is showing signs of deterioration, dilapidation and are otherwise in varying states of disrepair. A downspout along Bissett Place was disconnected, potentially contributing to water damage to the cast stone water table. Various brick pilasters on the south side of the building were carved out to accommodate downspouts, which may contribute to additional water infiltration into the building and could compromise the structural integrity of the building. Other portions of the masonry façade feature cracks with significant vertical displacement. Portions of exposed wood sheathing and wood trim around various openings exhibit various stages of rot.

As such, the deteriorated and dilapidated conditions, faulty arrangement or design and obsolete layout of the exterior of the building and various improvements are detrimental to the safety, health, morals and welfare of the community.

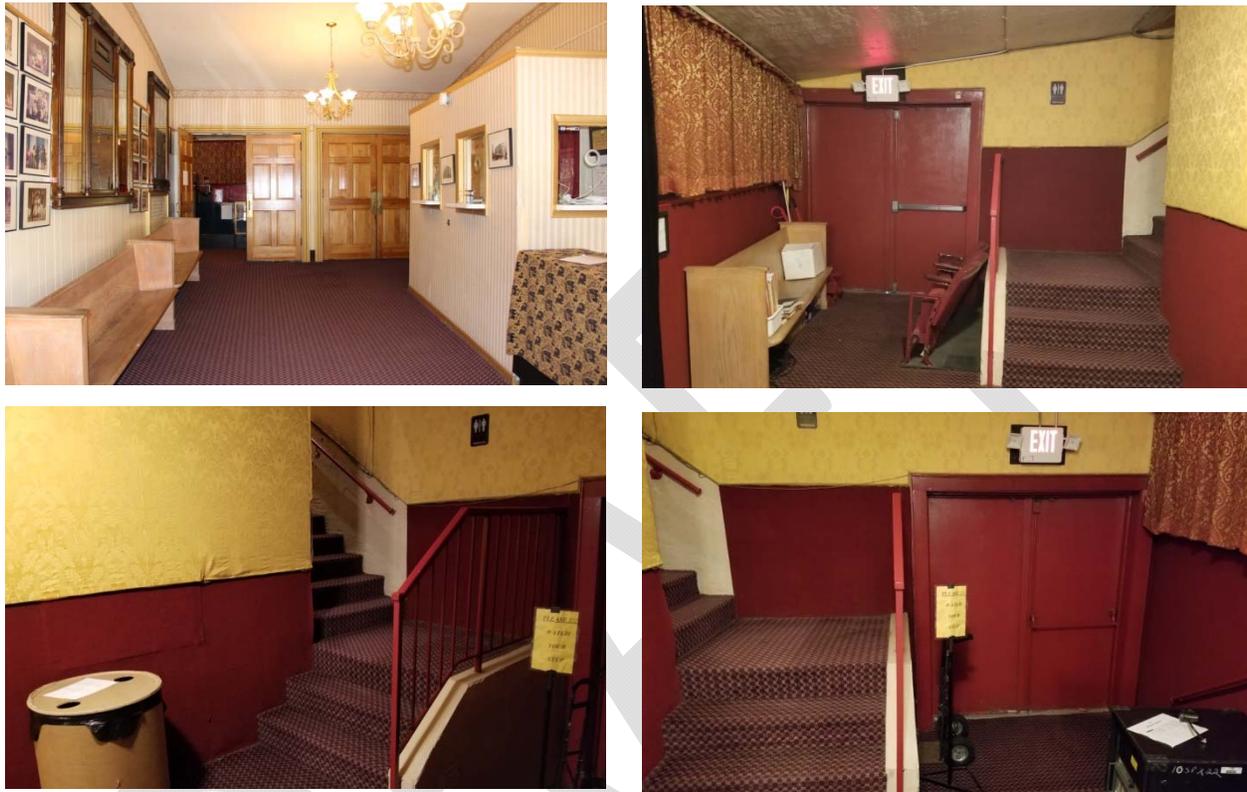
Building Interior Conditions – Lobby & Access

The present layout of the theater is obsolete by current design standards. The Forum Theater is flanked by two leaseholds, currently a barbershop and a photography studio, and the ticket office is essentially an enclosed box within the lobby. This arrangement significantly limits the overall size of the lobby which is intended to serve hundreds of theater patrons.

Access to the fire doors is limited, with equipment and furniture being stored along, if not within, the path of fire egress. Complicating access to the fire doors on the north side of the building is the need to traverse a set of stairs without the ability to use a handrail. There is no handrail on the left side while the handrail on the right side is blocked by sound equipment being stored at the top of the stairs. There is a sign at the base of the stairs displaying "Please!!! Watch Your Step".

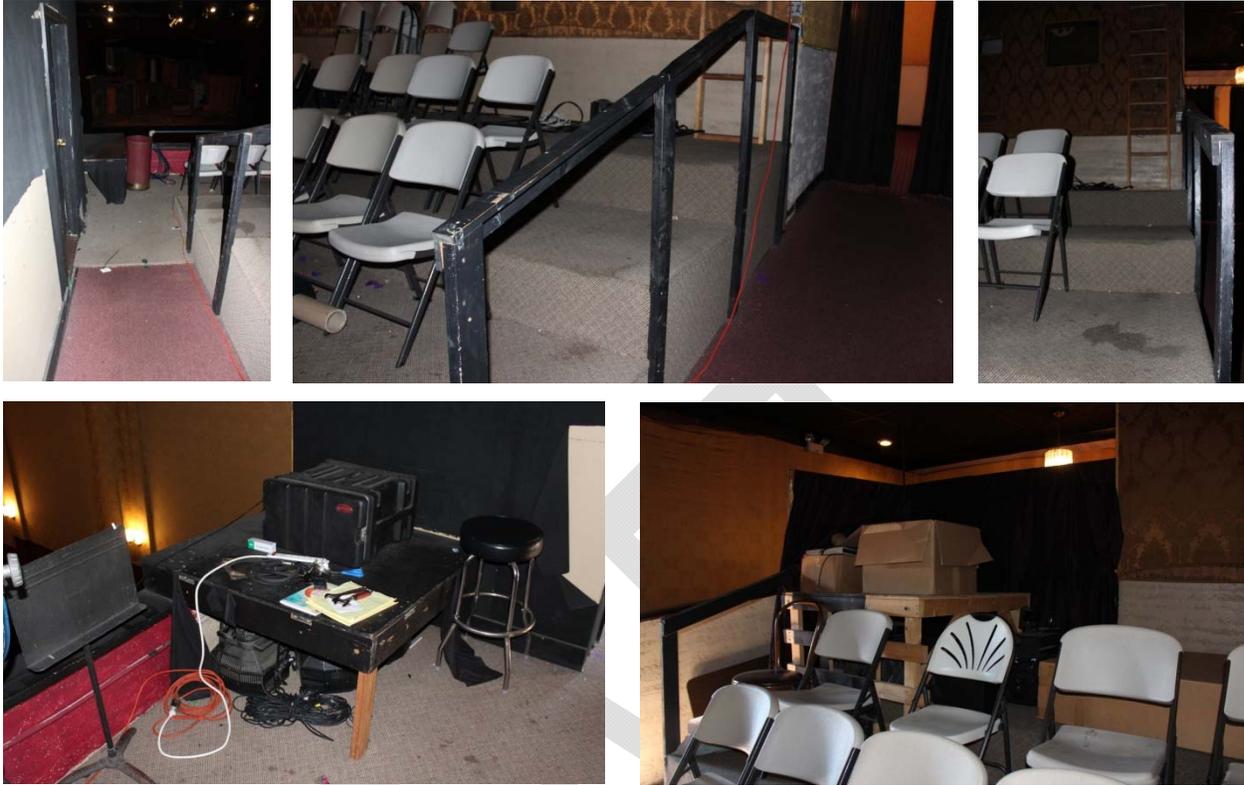
Building Interior Conditions – Balcony

The second floor balcony does not appear to be intended for public assembly, as the balcony does not have permanent seating (dozens of folding chairs are provided) and the majority of the area is generally not accessible. There is no elevator in the building and there are no intermediate stairs on the flanking ends of the tiered balcony. One must step up nearly a foot to gain access to the second row and each row beyond. The wood-frame handrail lacks balusters, which is a dangerous condition. Several portions of the balcony are being used for storage, there is exposed electrical wiring throughout and various floor and wall finishes are showing signs of deterioration, such as worn, stained or ripped fabrics.

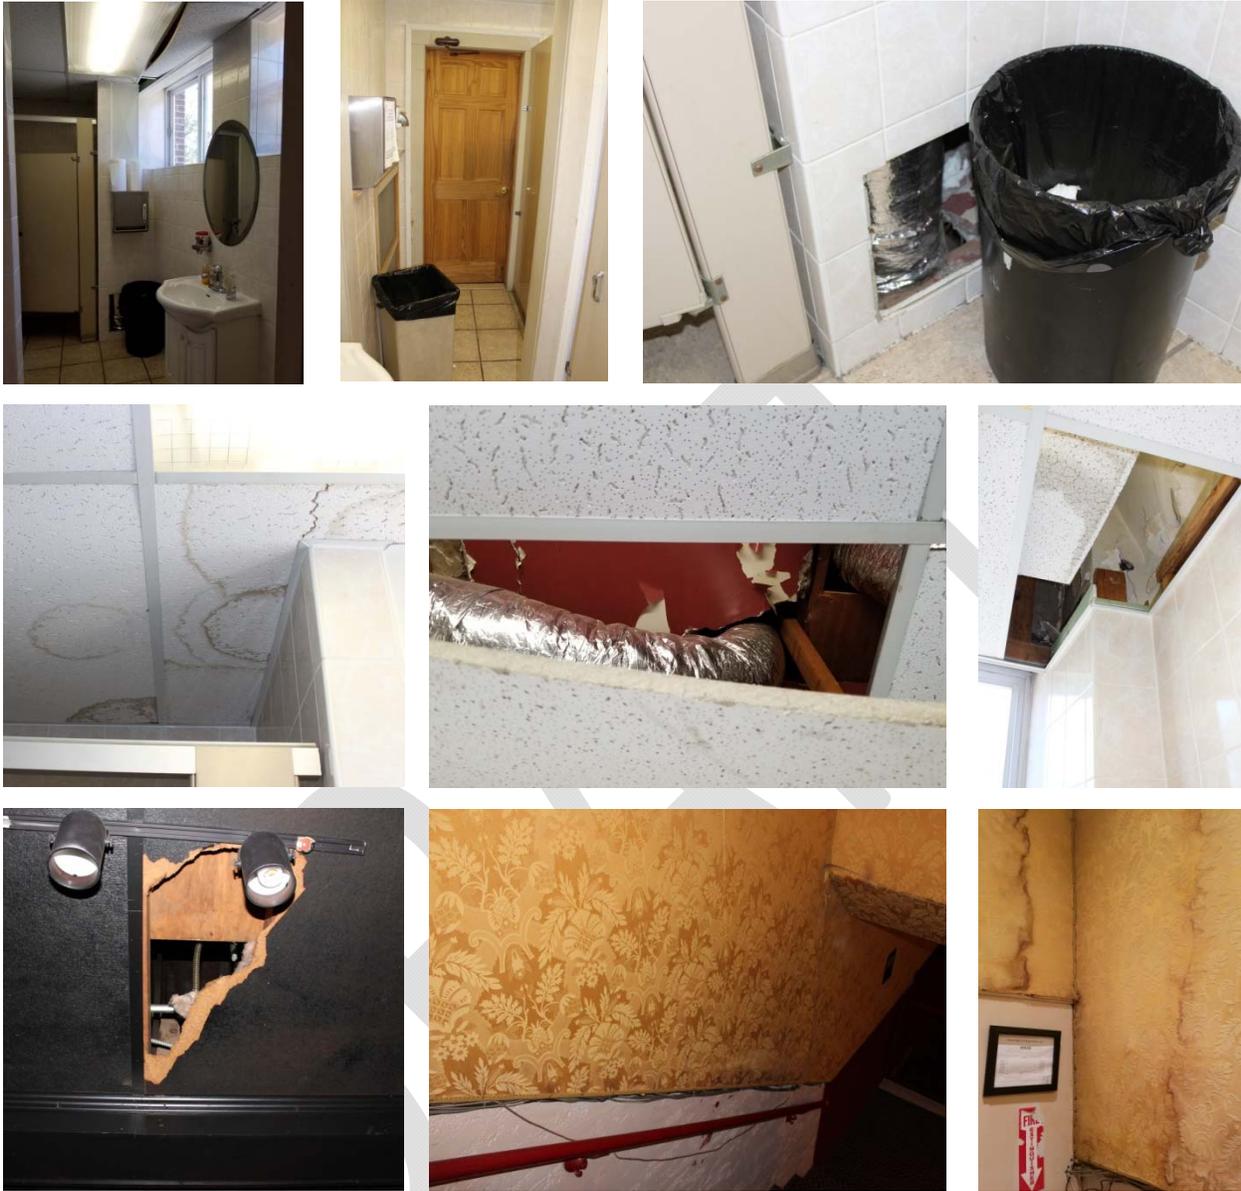
Building Interior Conditions – Second Floor

The second floor restrooms are narrow and small; in the women's restroom, the placement of the trash receptacle significantly restricts access and mobility. The restrooms are in various states of disrepair, with openings in the walls and various ceiling tiles that are water-damaged, broken or missing. Throughout the remainder of the second floor, there are broken ceiling tiles above the balcony, exposed wiring along the stairway and evidence of significant water damage along the exterior walls. Most of the wall finishes are in varying states of disrepair.

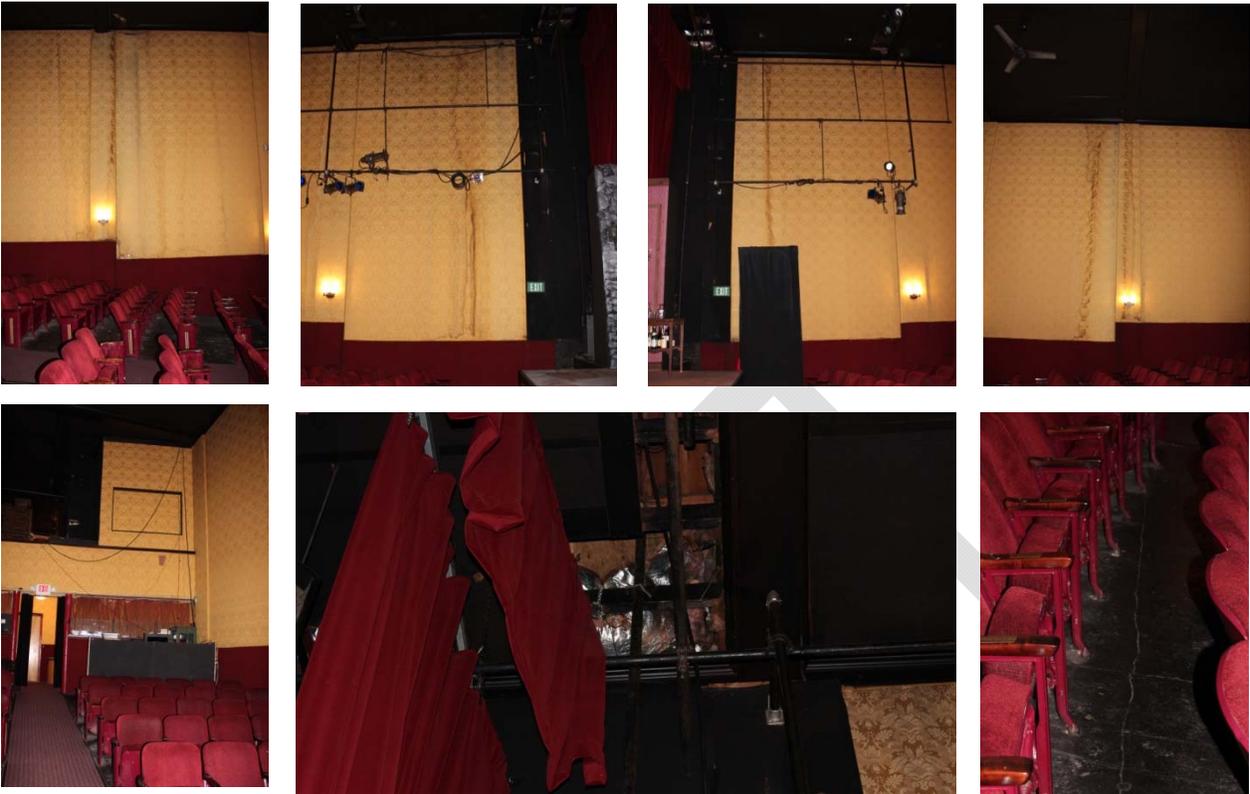
Building Interior Conditions – Theater Seating Area

In the main theater, there is evidence of significant water damage along the exterior walls. Most of the wall covering material is in varying states of disrepair. At the rear of the theater, there are hanging electrical wires and various ceiling tiles that have holes or are missing, over the seating area. There is also a large crack in the floor, near the center of the theater.

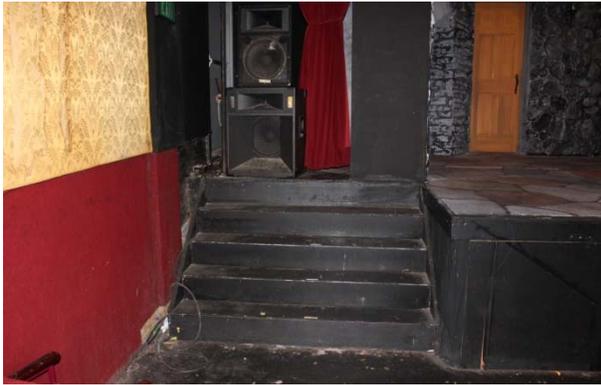
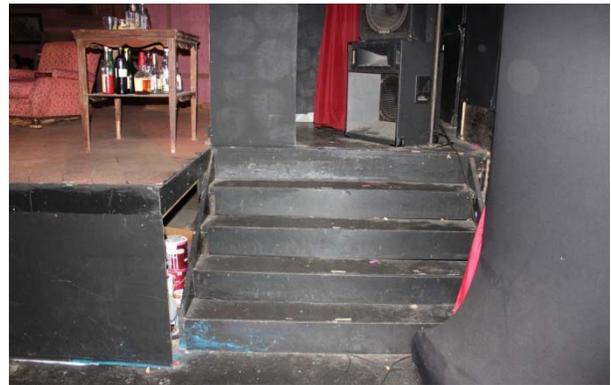
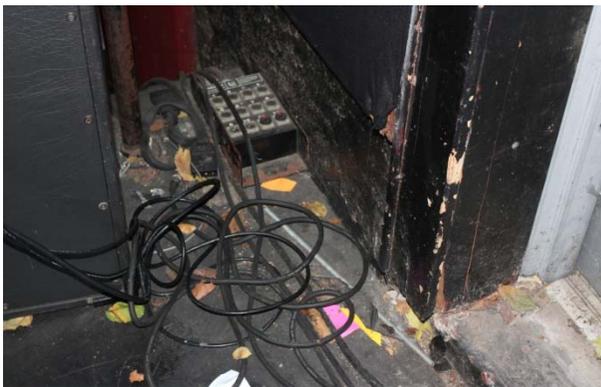
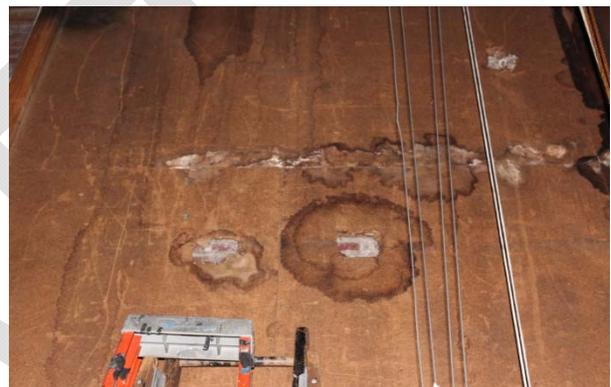
Building Interior Conditions – Theater Stage

Access to the stage is significantly constricted and there is a missing wall panel adjacent to the stairs on the right side of the stage, exposing the storage area to the seating area. There are exposed electrical wiring throughout and, again, there is evidence of significant water damage along the exterior walls. In fact, part of the masonry wall can be seen from the interior. The furnace is actually located on the stage, which limits the usable area of the stage for shows, and the wood-frame handrail for the stairway to the basement lacks balusters, which is a dangerous condition for those who are working in the theater.

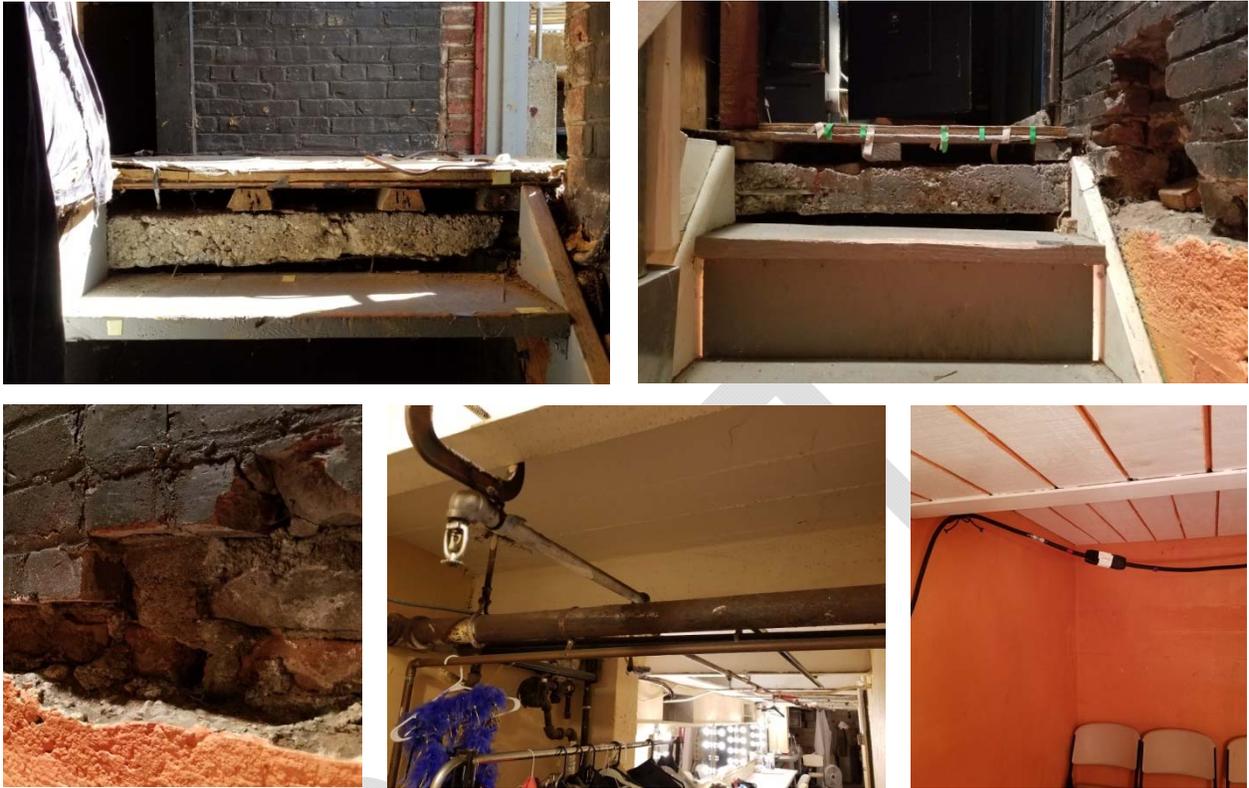
Building Basement Conditions

The basement stairs are missing the uppermost riser, exposing the deteriorating slab (and rebar) under the wood floor. There is a large hole in the masonry wall, just above the top of the foundation wall. Further into the basement, pipes are in various states of disrepair and there are exposed/hanging electrical wires, which is an unwholesome condition for those who are working in the theater.

Taken together, the deteriorated and dilapidated conditions, faulty arrangement or design and obsolete layout of various features of the interior of the building are detrimental to the safety, health, morals and welfare of the community.

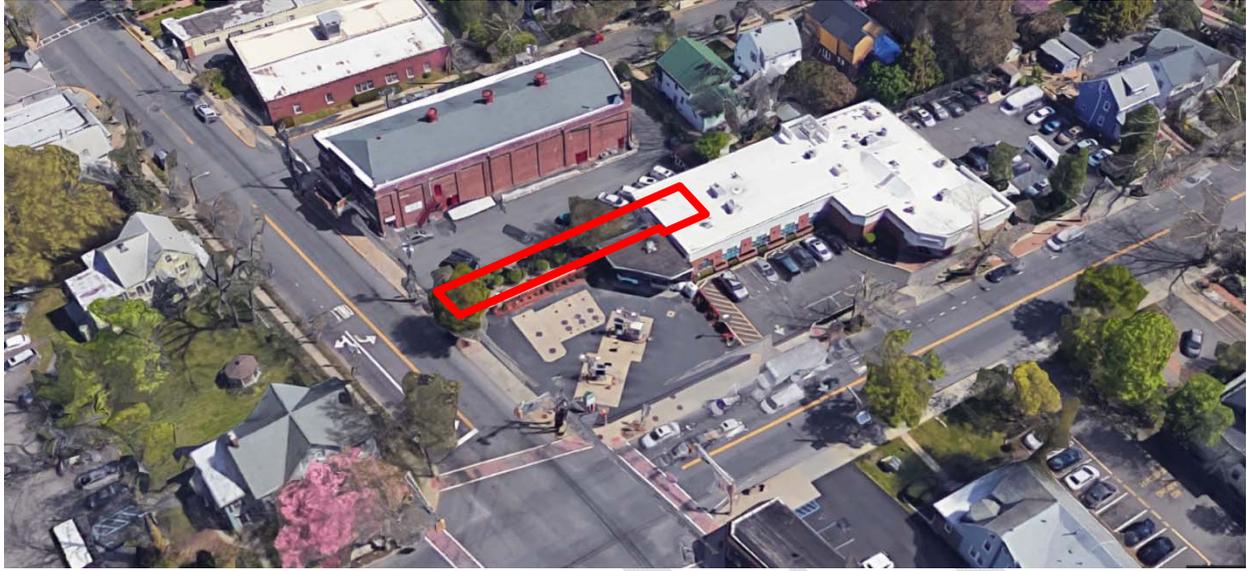
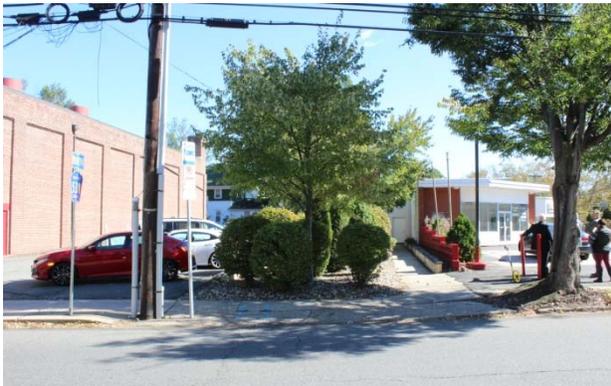
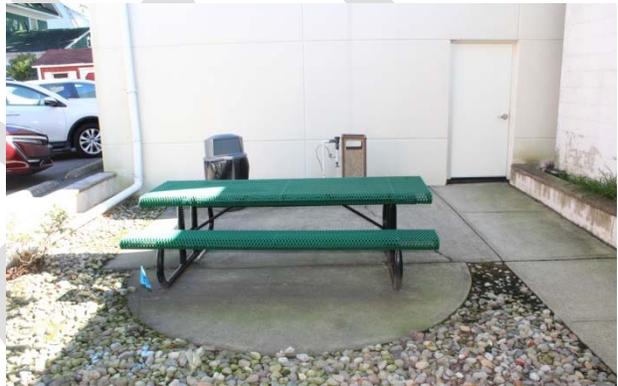
Block 183.02, Lot 5.01: 260-264 Amboy Avenue (University Radiology)

Block 183.02, Lot 5.01 is a narrow interior lot, with only 22.01 feet of frontage along the east side of Main Street, distant 75 feet north of Amboy Avenue, and having an average depth of over 117 feet as measured from Main Street. This lot is a small portion of the University Radiology property, whereas the portion of the property on lots 8.01, 9, 10, 11, 12, 13, 14, 15, 16 and 17.01 have frontage and otherwise mainly faces and relates to Amboy Avenue, situated east of the vacant gas station property.

This narrow lot is essentially a large landscaping bed, situated between the Forum Theatre and the vacant gas station. At the rear of the lot is a small outdoor area for the University Radiology employees and at the extreme rear of the lot is a 25 foot by 25 foot section of the northwest corner of the University Radiology building.

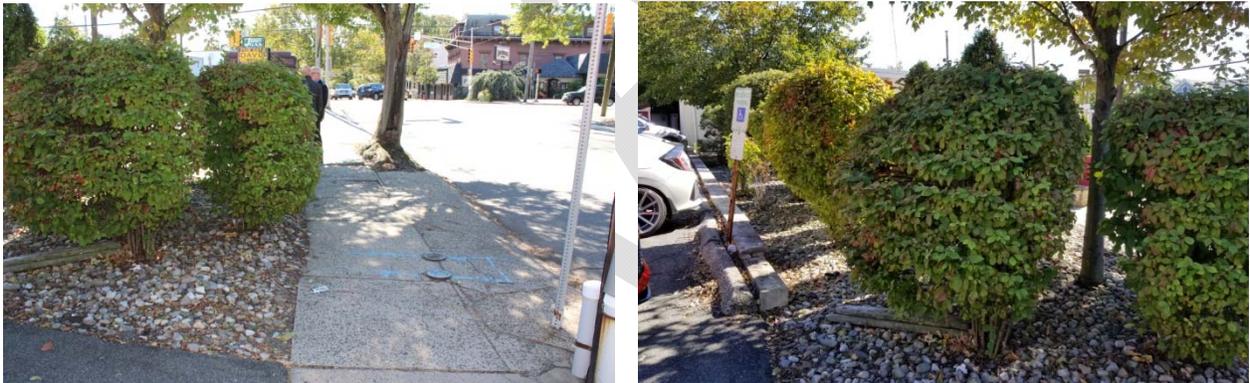
Streetscape Conditions

Along the streetscape frontage along Main Street, the sidewalk extends to a depressed curb along the street, likely a remnant of a former driveway serving the prior automobile dealership use. This apparent condition may result in driver confusion, as this former driveway is in very close proximity to the active driveway serving the Forum Theatre and near the driveway of the former gas station on its other side.

Additionally, the private walkway, public sidewalk and apparent former driveway apron show signs of deterioration as evidenced by settlement contributing to ponding, as well as cracked, broken and missing pavement. The uplifted water utility caps within the public sidewalk may potentially present a tripping hazard.

Finally, the landscaping bed consists of mainly overgrown shrubs and a couple trees in otherwise fair condition; however, there is no natural vegetative ground cover whatsoever. The landscaping bed features large loose stones, which is generally discouraged by Metuchen's design standards and in cases along a walkway, particularly along a public sidewalk, may not be permitted. Migration of loose stones into the path of the public sidewalk or in the street may potentially present another tripping hazard and contribute to property damage.

As such, the deteriorated and dilapidated conditions, faulty arrangement or design and obsolete layout of various improvements are detrimental to the safety, health, morals and welfare of the community and, again, can be more effectively developed as part of a larger comprehensive plan.

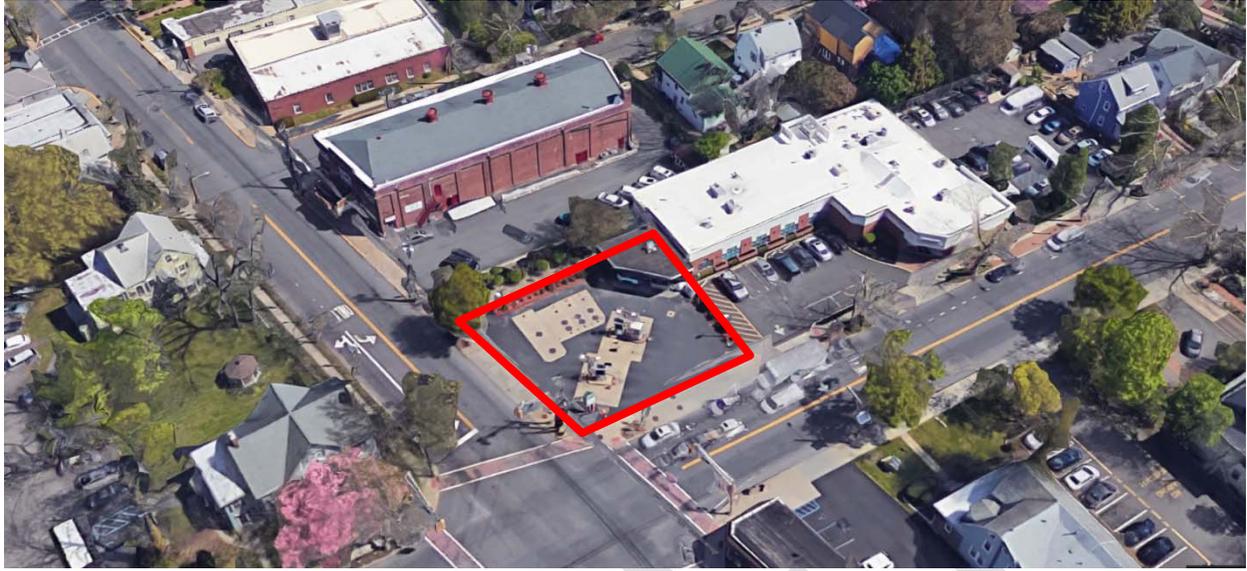
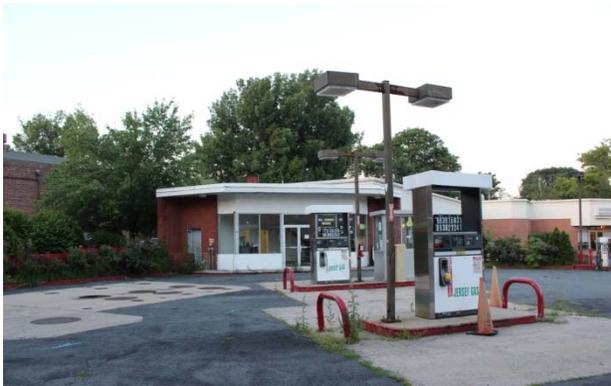
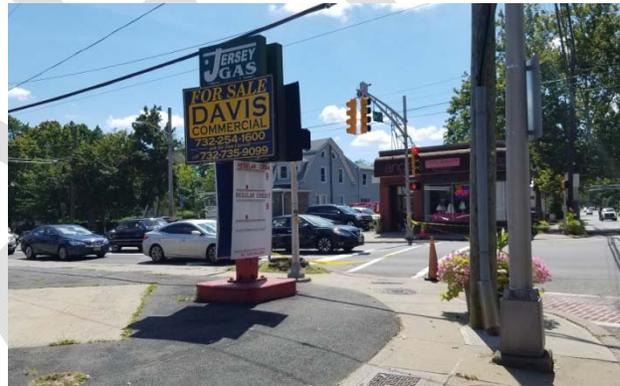
Block 183.02, Lots 5.02, 6-8: 304 Main Street (Jersey Gas)

Block 183.02, Lots 5.02, 6, 7 and 8 is a corner lot, with 75 feet of frontage along the east side of Main Street and 75 feet of frontage along the north side of Amboy Avenue, and having an average depth of 82.61 feet as measured from Main Street. This property contains a vacant gas station, with two uncovered fueling islands situated near the center of the parking area and a small one-story building at the northeast corner of the property. The building suffered fire damage in 2016 and has been abandoned since that time. The paved area takes up nearly the entirety of the property and has egress and ingress driveways from both Main Street and Amboy Avenue. As such, the property is nearly 100% impervious.

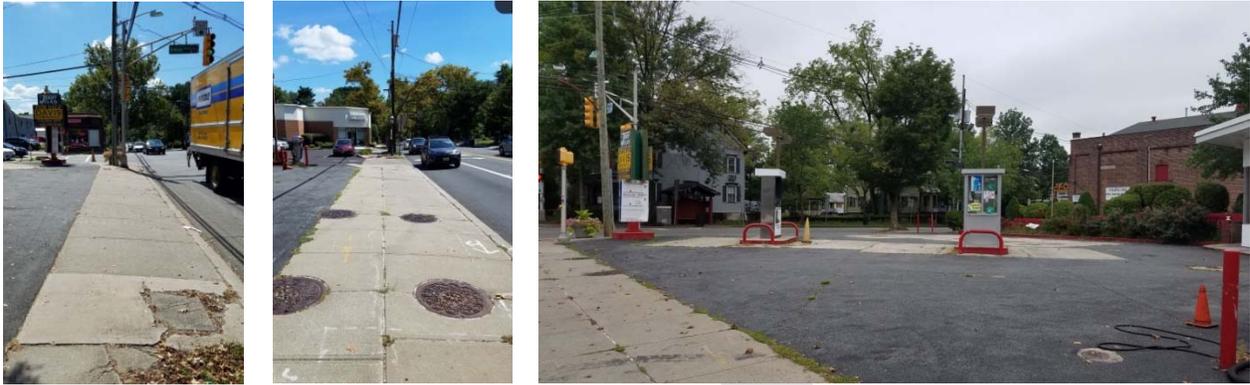
Parking Area Layout & Design

The present layout of the parking lot is obsolete by current land use planning and does not include adequately designed vehicular ingress and egress or defined parking areas. There is an access point along both Main Street and Amboy Avenue, each accommodating ingress and egress. However, these driveways are excessive in width, much wider than the standard driveway width of 24 feet, and they are both in very close proximity to the highly-travelled intersection of Main Street and Amboy Avenue.

The oversized access points permit vehicles to enter and exit the property by way of a left turn, despite there being a double-yellow line present on both Main Street and Amboy Avenue, along with dedicated turn lanes. Taken together, these apparent conditions may result in driver confusion and contribute to a circulation pattern that is unsafe and dangerous.

Additionally, the excessively wide access points also contribute to long walking distances for pedestrians cross them, which is counter to the goals and objectives of the Borough's Complete Streets policies, particularly for a property located on Main Street within the downtown area and contributes to an unsafe pedestrian environment.

Finally, various areas of the parking lot show signs of deterioration as evidenced by vegetative overgrowth, settlement contributing to ponding, as well as cracked, broken and missing pavement.

As such, the deteriorated and dilapidated conditions, faulty arrangement or design and obsolete layout of various parking area improvements are detrimental to the safety, health, morals and welfare of the community.

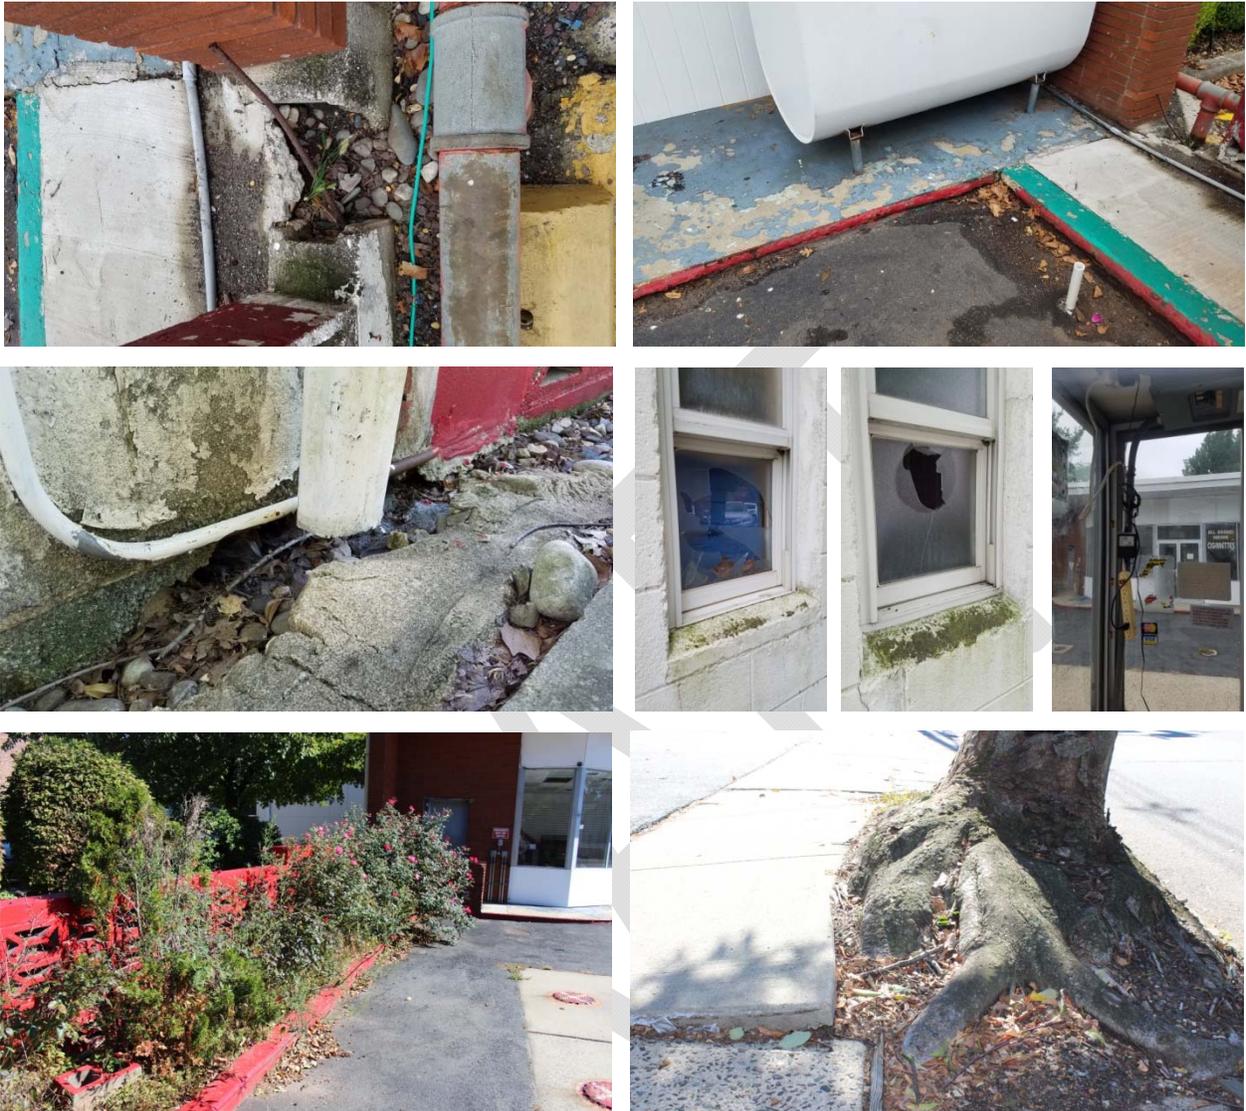
Site Conditions

While access to the interior of the building was not gained, a visual inspection indicates that the exterior of the building and various improvements are showing signs of deterioration, dilapidation and are otherwise in a state of major disrepair. Various portions of the pavement are broken, with exposed rebar, paint chipping under the exterior oil tank and a roof leader did not have an elbow to displace stormwater away from the building, leading to severe water damage to the bottom of the block wall and possibly under the slab of the building.

There are broken windows at the rear of the building and inside the enclosure adjacent to the fuel dispensary are exposed/hanging electrical wires and a power strip suspended by such wires. Around the perimeter of the property, there is various vegetative overgrowth, trash, and broken pieces of the CMU block wall within the landscaping area at the north end of the site and the uplifted public sidewalk may potentially present a tripping hazard.

As such, the deteriorated and dilapidated conditions, faulty arrangement or design and obsolete layout of the building and various improvements are detrimental to the safety, health, morals and welfare of the community and, again, can be more effectively developed as part of a larger comprehensive plan.
